RECONSTRUCTION AND ADAPTATION OF THE CURRENT HEALTH CARE CENTER BUILDING INTO
THE HEADQUARTERS OF THE MUNICIPALITY OF PUSTEC, ALBANIA

TECHNICAL REPORT

on the current conditions of the existing building
and the proposed interventions

April
2022

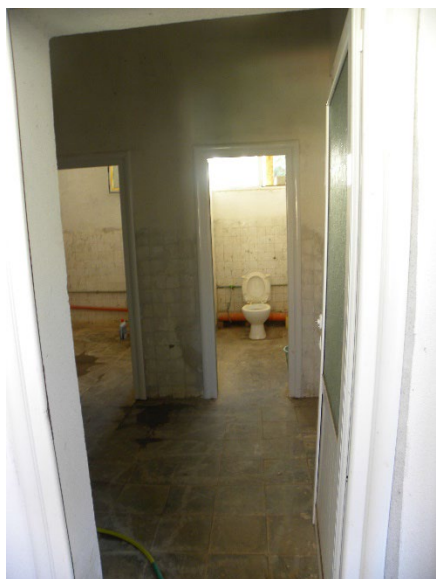
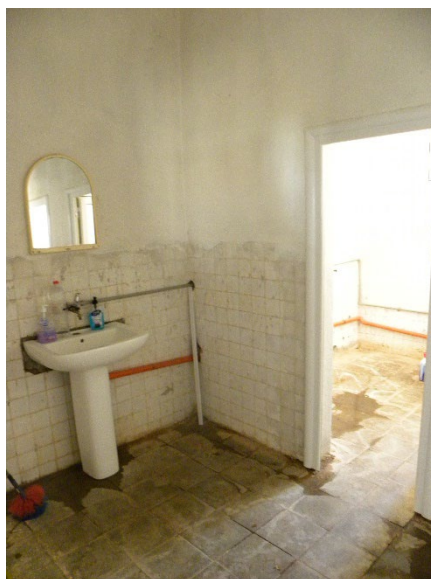
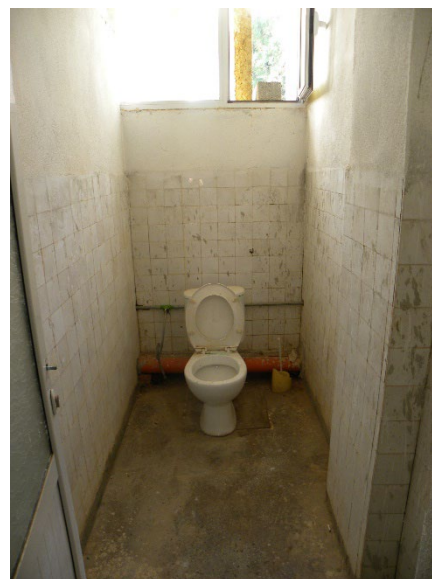
TOILETS

The current doors are mostly of wood, except toilet doors, which are replaced over the years with new ones in aluminum profiles. The toilets are the most problematic areas. The plumbing fixtures are replaced with new ones, but the tiles have not. As a result, the pipes of the water supply system as well as those of the sewerage are exposed. The floor and wall tiles in the toilets are covered in plaster and paint drops, which makes them aesthetically and hygienically inappropriate. There is no heating system installed in the building. The current solution is the wood stoves placed in some of the offices (the Fire Department). As for the lightning fixtures, new ones are installed in the corridors and the other ones are just incandescent lamps hanging from the ceilings.

The current structure, with its layout organization and volumetric composition, is easily suitable for these new functions, however it is necessary to make interventions in the masonry, to shift the door positions in some cases where this action can optimize the use of space. Toilets also need to be restructured, both in terms of layout organization and improvement of finishes.

Changes in toilets will also be associated with reapplying waterproofing layers on floors and walls. Also, the terrace layers will be remade, including waterproofing. The new network of electrical and plumbing installations will require the re-plastering of all surfaces, before painting them.

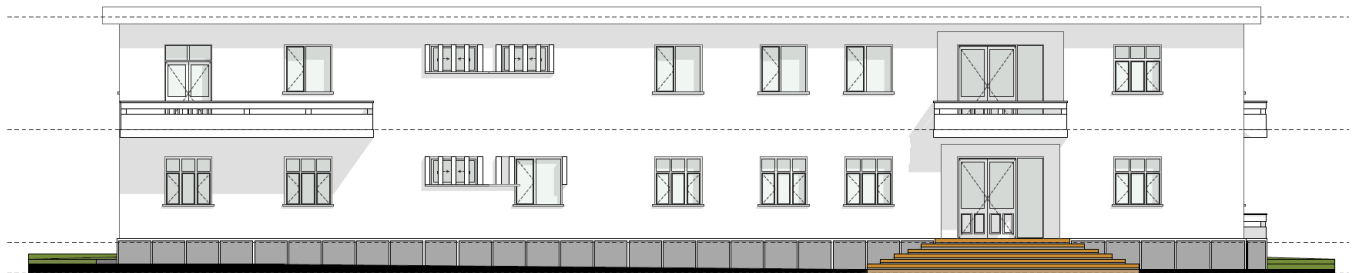
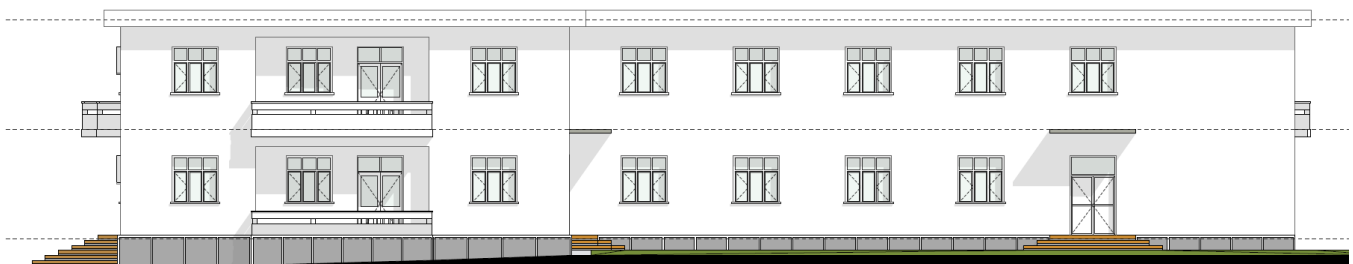
The façades of the building are coated in plaster and white-gray paint. The north-eastern and north-western facades are the significantly deteriorated, reflecting plaster loss areas and black mold due to humidity presence and lack of natural light exposure. There are three main types of windows applied in the building, which differ from one another from the material of the frame (wood or aluminum profile), the number of vertical profiles and opening types. The old windows of north-western and south-western façades are replaced with new ones. However, they do not meet the required standards of energy efficiency of the building.

The external appearance of the building will be subject to interventions that are mainly related to the qualitative aspect of the works and to a lesser extent to the aesthetic one. The building will be thermally insulated from the outside. As part of the improvement of the energy efficiency of the building, the windows and doors will be changed, which will be replaced with others, with a coefficient of thermal conductivity according to the standards.

At the aesthetic level, the intervention consists in creating joints near the windows and doors, to give the object a vertical accent, while highlighting the rhythmic composition of the openings in the facades.

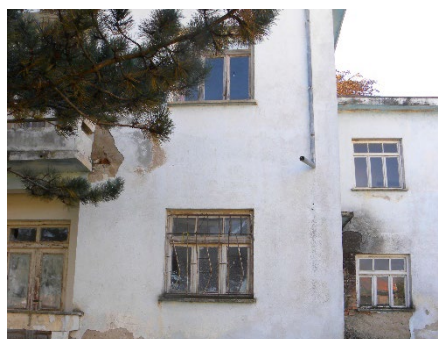
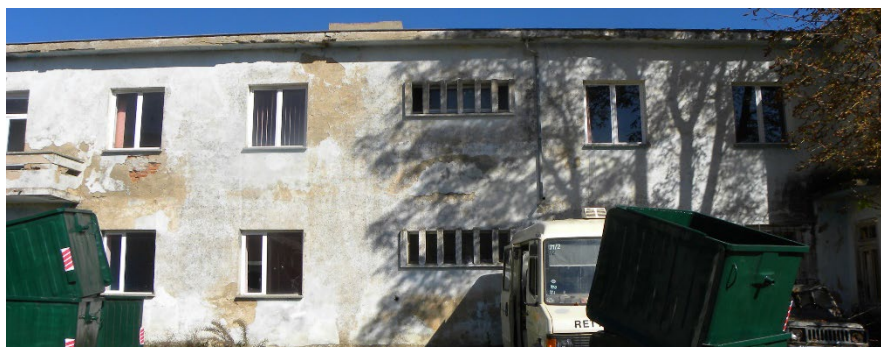
WINDOWS

The toilet windows are treated with special care to the detail, using vertical concrete elements in order to reduce the visibility from the outside, resulting in a very interesting architectonic detail which is worthy of preservation. The external doors vary in types as well, even though not so much in terms of dimensions. Some of them are replaced with aluminum profile doors, which do not meet the security requirements and those of energy efficiency for external doors.

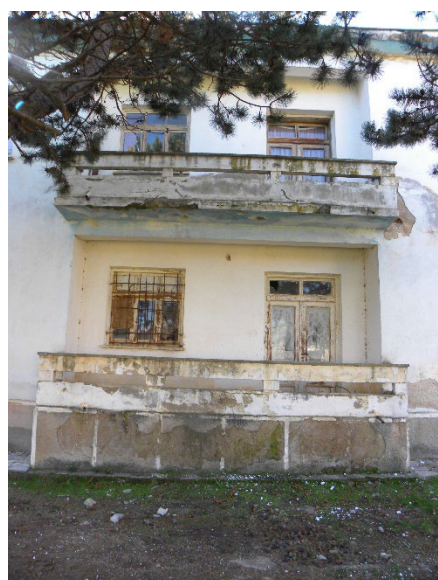
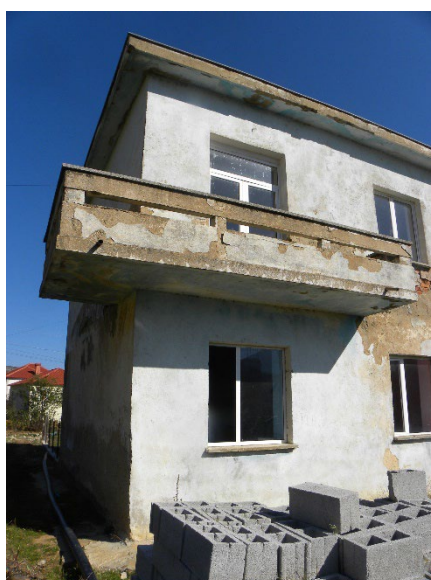
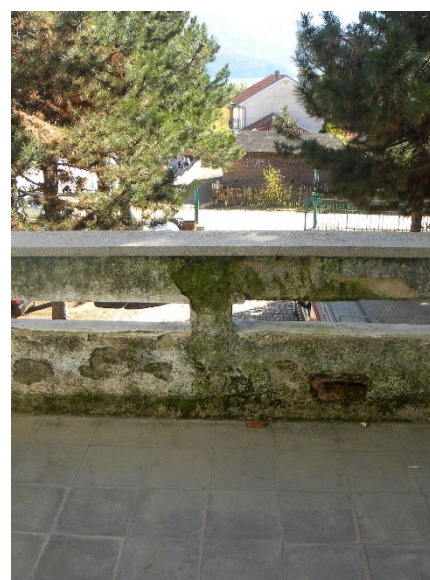
BALCONIES

Another detail applied in the façade are the balconies' parapets. They are usually found in residential buildings; however, they represent a typical detail of the architectonic language used during the period when the building was designed.

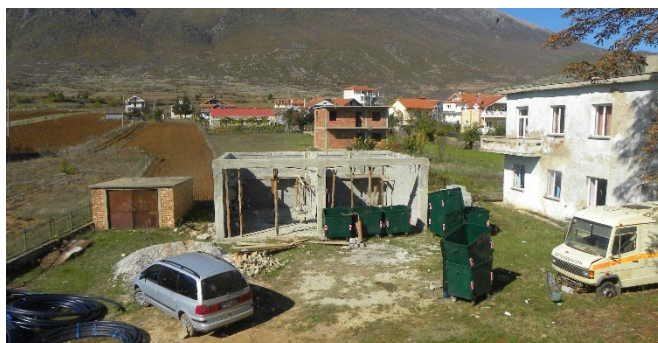
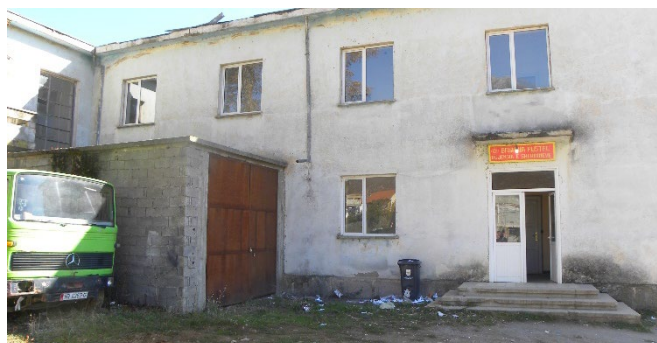
ADDITIONAL STRUCTURES

There are three new structures built inside the territory of the building, used as garages. One of them is a lateral addition to the main building in the western inside corner. One of the structures, the one sheltering two garages is incomplete.
