RECONSTRUCTION AND ADAPTATION OF THE CURRENT HEALTH CARE CENTER BUILDING INTO
THE HEADQUARTERS OF THE MUNICIPALITY OF PUSTEC, ALBANIA

TECHNICAL REPORT

on the current conditions of the existing building
and the proposed interventions

April
2022

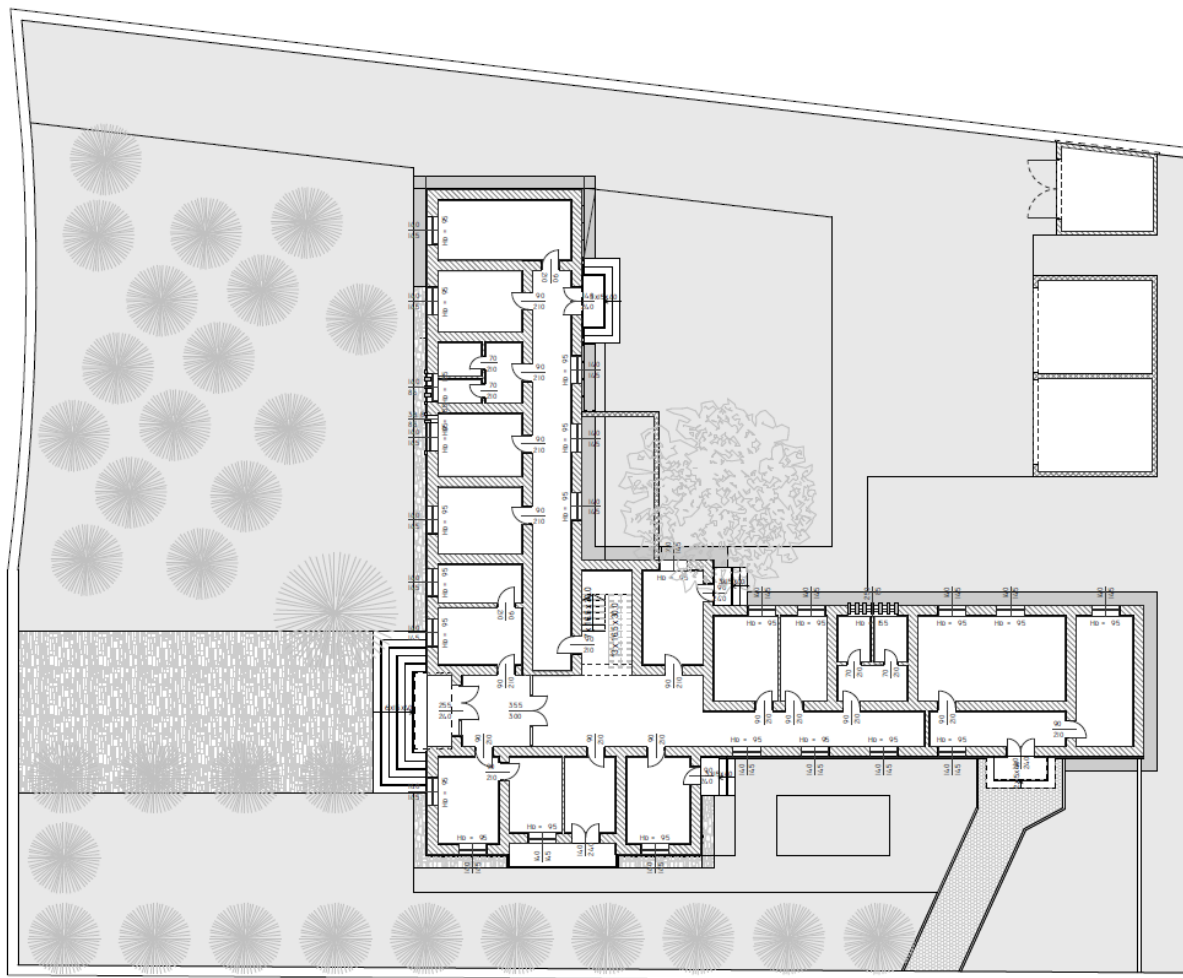
Landscape plan

The surrounding territory is mostly in its natural state. The south-eastern yard is partially paved in stones (the route leading toward the main entrance to the building) and partially planted with pine trees. A narrow pavement, covered in concrete or stone, surrounds the building along its perimeter. The property is defined by surrounding low walls and fence on top of them.

There are three new structures built inside the territory of the building, used as garages. One of them is a lateral addition to the main building in the western inside corner. One of the structures, the one sheltering two garages is incomplete.
